**SERVICE BULLETIN – Standard Rolling Roof Rig Base Assembly**

In an effort to assure the safety of, and to continuously improve the quality of our products, we at Sky Climber conduct internal quality audits and request feedback from our customers on their experiences using our products. Based on information generated from these activities, we have introduced a product concern with the Standard Rolling Roof Rig (RRR) 154-24-02 Base Weldment.

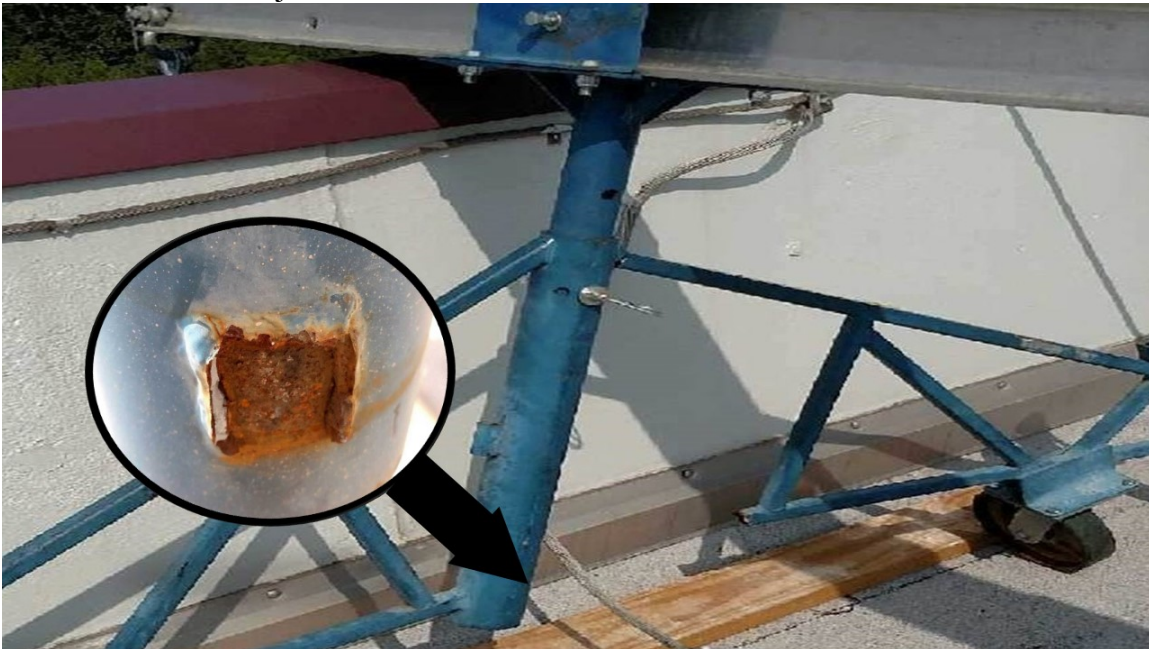
BACKGROUND: A customer reported that a weld broke on one side of a rolling roof rig while under load at a job site.

CURRENT INFORMATION: The supplied pictures indicate that a junction weld between one of the Bottom Weldment half and the DOM tube was only welded on 3 sides of the junction. All four connection joints of the 2 base halves and the center DOM tube should be welded on all 4 sides. NOTE: Other pieces within the base weldment half may be welded on only 3 sides per the 154-24-03 print.

**COMPLIANCE:** **MANDATORY** – The 4 weld connections indicated in the drawing below, must be welded continuously around on all 4 sides. If not, the unit should be removed from service and returned to Sky Climber for rework or replacement.
